ASBESTOS BULK SAMPLE COLLECTION & ANALYSIS

13400 West Outer Drive
Detroit, MI 48239

ETC Job #: 283121

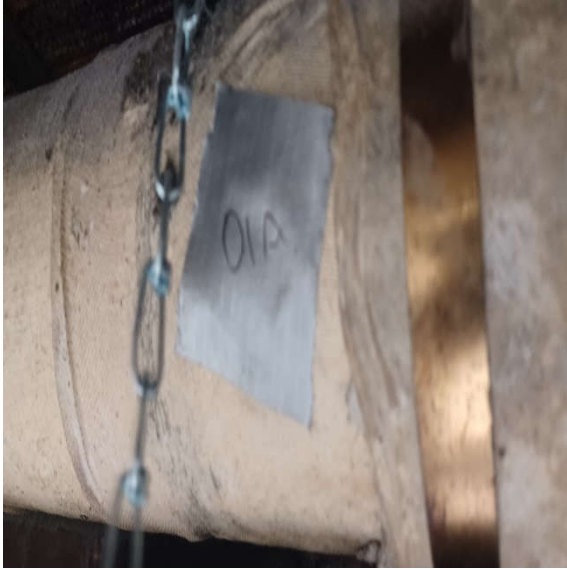
Material 01A

- **Pipe Insulation/Mag (Grey) was found to be positive for hazardous asbestos**
- **Pipe Insulation/Packing (Grey) was found to be positive for hazardous asbestos**

Sample	Description	Appearance	% Fibrous	% Non-Fibrous	% Asbestos
1827927 1A FS1 Layer-1 Analyst: Chris Canilao Date Analyzed : 10/20/2025	Pipe Insulation / Mag - Grey - HA(1)	Grey Fibrous Homogenous	PLM Trace Cellulose	PLM 60% Other	PLM 40% Chrysotile
1827927 1A FS1 Layer-2 Analyst: Chris Canilao Date Analyzed : 10/20/2025	Fibrous Backing	Grey Fibrous Homogenous	PLM 98% Cellulose	PLM 2% Other	PLM None Detected
1827928 1B FS1 Layer-1 Analyst: Chris Canilao Date Analyzed : 10/20/2025 Layer Not Analyzed		Positive Stop			
1827928 1B FS1 Layer-2 Analyst: Chris Canilao Date Analyzed : 10/20/2025	Fibrous Backing	Grey Fibrous Homogenous	PLM 98% Cellulose	PLM 2% Other	PLM None Detected
1827929 1C FS1 Layer-1 Analyst: Chris Canilao Date Analyzed : 10/20/2025 Layer Not Analyzed		Positive Stop			
1827929 1C FS1 Layer-2 Analyst: Chris Canilao Date Analyzed : 10/20/2025	Fibrous Backing	Grey Fibrous Homogenous	PLM 98% Cellulose	PLM 2% Other	PLM None Detected

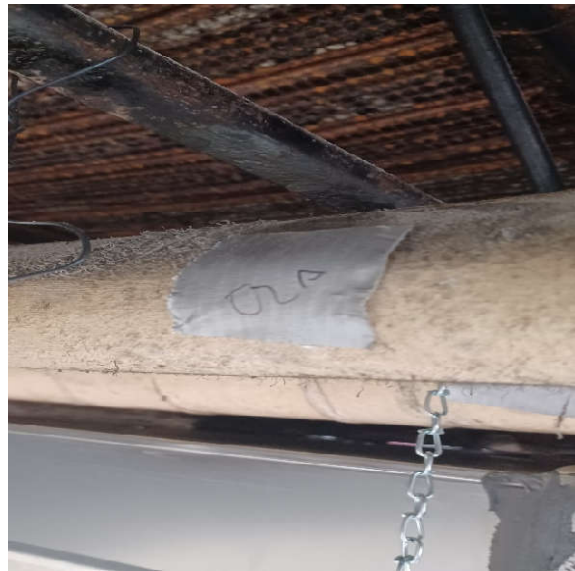
Material 02A

Sample	Description	Appearance	% Fibrous	% Non-Fibrous	% Asbestos
1827930 2A FS1 Layer-1 Analyst: Chris Canilao Date Analyzed : 10/20/2025	Pipe Insulation / Packing - Grey - HA(2)	Grey Fibrous Homogenous	PLM Trace Cellulose	PLM 60% Other	PLM 40% Chrysotile
1827930 2A FS1 Layer-2 Analyst: Chris Canilao Date Analyzed : 10/20/2025	Fibrous Backing	Grey Fibrous Homogenous	PLM 98% Cellulose	PLM 2% Other	PLM None Detected
1827931 2B FS1 Layer-1 Analyst: Chris Canilao Date Analyzed : 10/20/2025 Layer Not Analyzed		Positive Stop			
1827931 2B FS1 Layer-2 Analyst: Chris Canilao Date Analyzed : 10/20/2025	Fibrous Backing	Grey Fibrous Homogenous	PLM 98% Cellulose	PLM 2% Other	PLM None Detected
1827932 2C FS1 Layer-1 Analyst: Chris Canilao Date Analyzed : 10/20/2025 Layer Not Analyzed		Positive Stop			
1827932 2C FS1 Layer-2 Analyst: Chris Canilao Date Analyzed : 10/20/2025	Fibrous Backing	Grey Fibrous Homogenous	PLM 98% Cellulose	PLM 2% Other	PLM None Detected

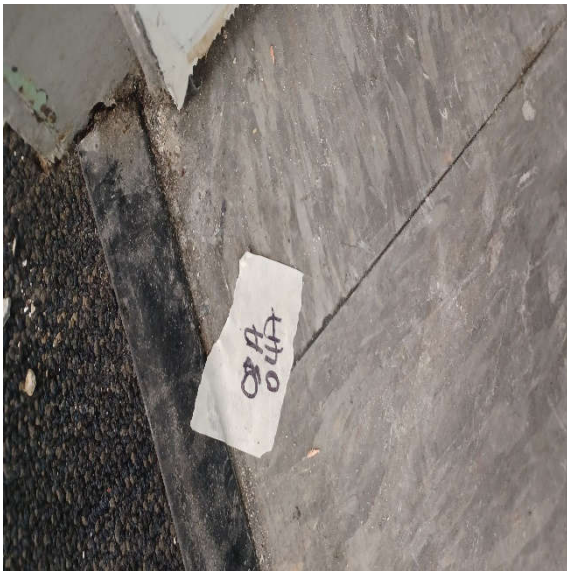
Material 03A, 04A

Sample	Description	Appearance	% Fibrous	% Non-Fibrous	% Asbestos
1827933 3A FS4 Layer-1 Analyst: Chris Canilao Date Analyzed : 10/20/2025	Floor / Tile - Grey - HA(3)	Grey Non-Fibrous Homogenous	PLM Trace Cellulose	PLM 100% Other	PLM None Detected
1827934 3B FS9 Layer-1 Analyst: Chris Canilao Date Analyzed : 10/20/2025	Floor / Tile - Grey - HA(3)	Grey Non-Fibrous Homogenous	PLM Trace Cellulose	PLM 100% Other	PLM None Detected
1827935 3C FS6 Layer-1 Analyst: Chris Canilao Date Analyzed : 10/20/2025	Floor / Tile - Grey - HA(3)	Grey Non-Fibrous Homogenous	PLM Trace Cellulose	PLM 100% Other	PLM None Detected
1827936 4A FS4 Layer-1 Analyst: Chris Canilao Date Analyzed : 10/20/2025	Floor / Tile Mastic - Tan - HA(4)	Tan Non-Fibrous Homogenous	PLM Trace Cellulose	PLM 100% Other	PLM None Detected
1827936 4A FS4 Layer-2 Analyst: Chris Canilao Date Analyzed : 10/20/2025	Adhesive	Clear/Gray Non-Fibrous Homogenous	PLM Trace Cellulose	PLM 100% Other	PLM None Detected

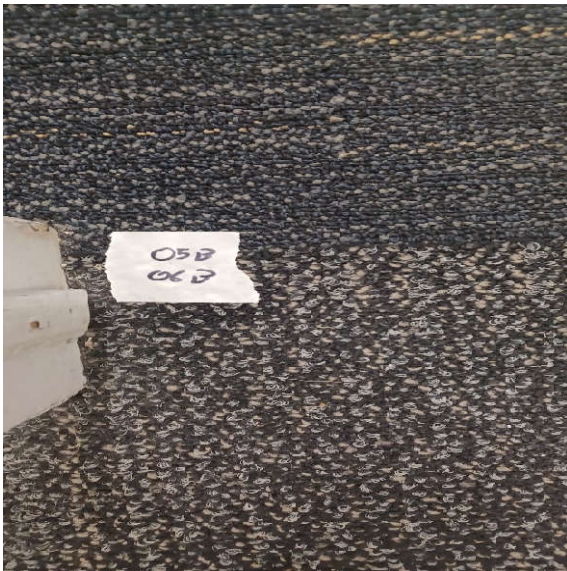
Material 05B, 06B

1827940 5B FS12 Layer-1 Analyst: Chris Canilao Date Analyzed : 10/20/2025	Floor / Tile - Blue/Grey - HA(5)	Blue/Grey Non-Fibrous Homogenous	PLM Trace Cellulose	PLM 100% Other	PLM None Detected

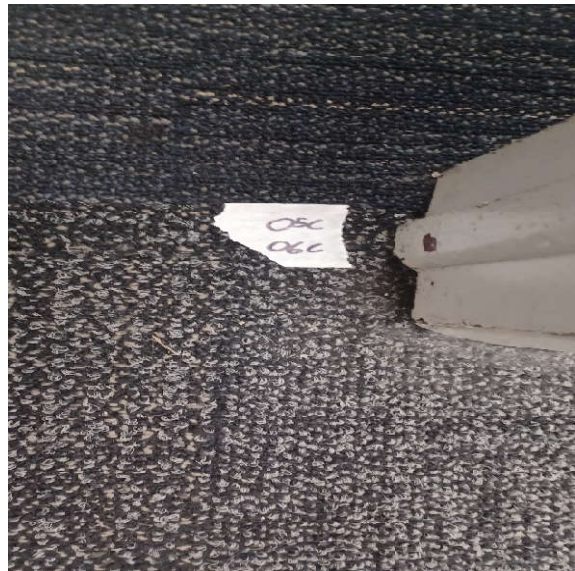
Material 05C, 06C

Sample	Description	Appearance	% Fibrous	% Non-Fibrous	% Asbestos
1827941 5C FS16 Layer-1 Analyst: Chris Canilao Date Analyzed : 10/20/2025	Floor / Tile - Blue/Grey - HA(5)	Blue/Grey Non-Fibrous Homogenous	PLM Trace Cellulose	PLM 100% Other	PLM None Detected
1828884 006A FS9 Layer-1 Analyst: Chris Canilao Date Analyzed : 10/20/2025	Floor / Tile Mastic - Tan - HA(6)	Tan Non-Fibrous Homogenous	PLM Trace Cellulose	PLM 100% Other	PLM None Detected
1828884 006A FS9 Layer-2 Analyst: Chris Canilao Date Analyzed : 10/20/2025	Adhesive	Green Non-Fibrous Homogenous	PLM Trace Cellulose	PLM 100% Other	PLM None Detected
1828885 006B FS12 Layer-1 Analyst: Chris Canilao Date Analyzed : 10/20/2025	Floor / Tile Mastic - Tan - HA(6)	Tan Non-Fibrous Homogenous	PLM Trace Cellulose	PLM 100% Other	PLM None Detected
1828885 006B FS12 Layer-2 Analyst: Chris Canilao Date Analyzed : 10/20/2025	Adhesive	Green Non-Fibrous Homogenous	PLM Trace Cellulose	PLM 100% Other	PLM None Detected
